Manhole Inspection Summary

Manhole # S590__005MH

Insp Date: **7/25/08 9:50 AM**

Location Address: **4401 odonnell st**

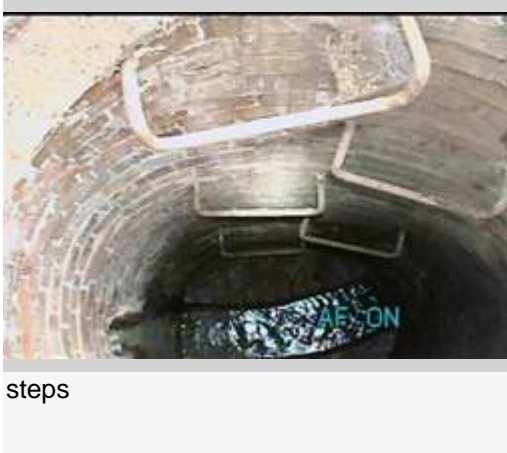
Defect 1

Steps Count: **5** Missing: **0** ☒ **Corroded**

steps

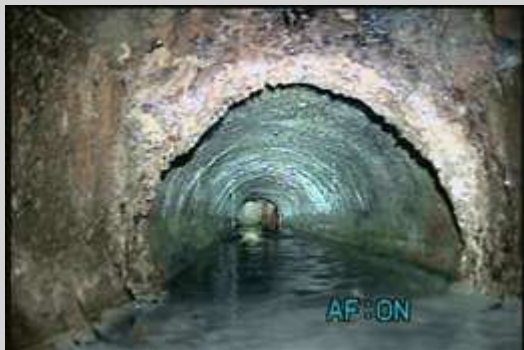
12 O'Clock Outflow

12 in. Circular Gravity Sewer
Pipe Out @ 12 O'Clock

Infiltration: None Pipe Seal Cond: Unknown

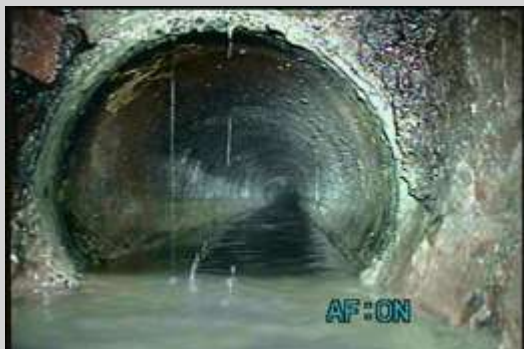
7 O'Clock Inflow

12 in. Circular Gravity Sewer
Pipe In @ 7 O'Clock

Infiltration: None Pipe Seal Cond: Unknown

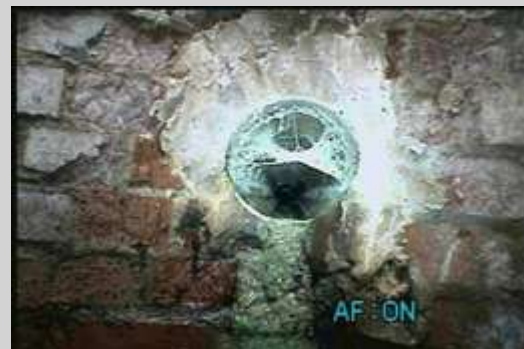
Drop In @ 7 O'Clock

Drop: Outside Direct

Drop Condition: Open
